Warranty Extension: 2016-20 HR-V CVT Premature Belt Deterioration

Supersedes 21-047, Dated April 27, 2021, to revise the information highlighted in **yellow**.

Replace the Continuously Variable Transmission (CVT).

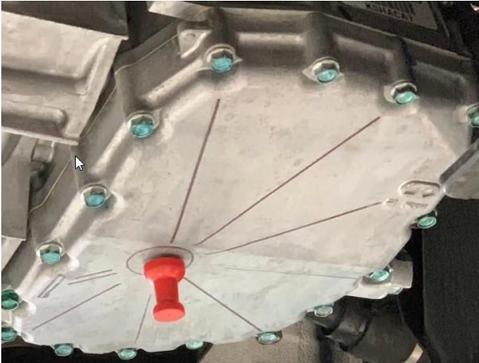
- Provide a clear picture of the magnet sticking on the CVT oil pan at the inspection area (this picture should have been taken during the CVT magnet inspection).

- Provide a clear picture of the magnet sticking on the CVT oil pan at the inspection area (this picture should have been taken during the CVT magnet inspection).
- Drain the CVT fluid through a paint strainer as shown below. Provide a clear picture of the inside of the strainer showing any contamination.
- Provide a clear picture of the magnet on the end of the oil pan drain plug.

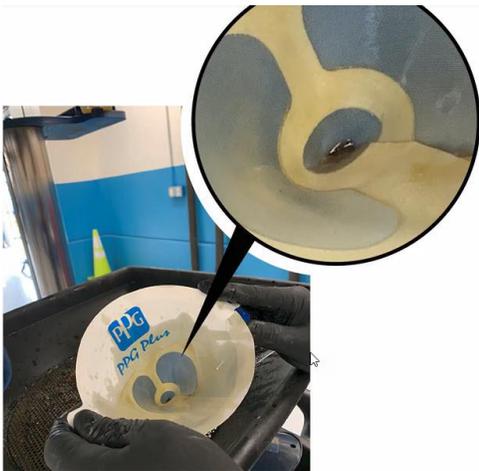
- Drain the CVT fluid through a paint strainer as shown below. Provide a clear picture of the inside of the strainer showing any contamination.

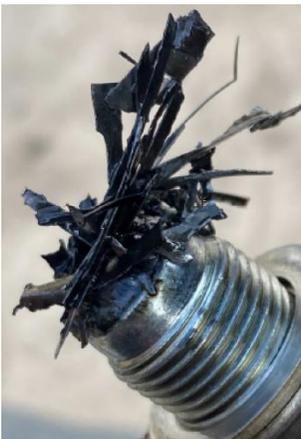
- Provide a clear picture of any contaminates on the end of the oil pan drain plug.

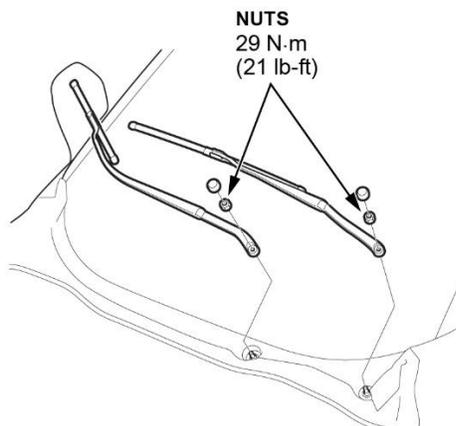
1. Remove wiper arms and cowl cover.

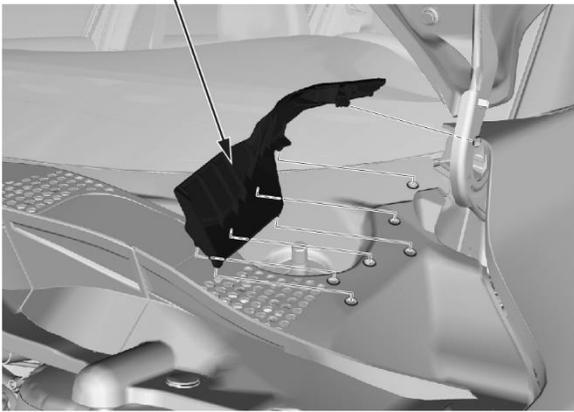
FRONT FENDER COVER

2. Remove the left and right front fender covers.

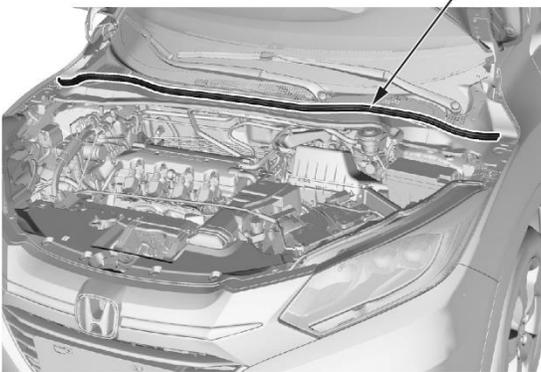
HOOD REAR SEAL

3. Remove the hood rear seal.

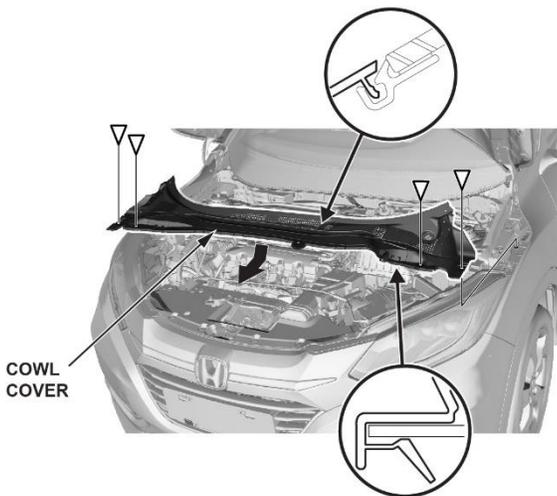
4. Remove the cowl cover.

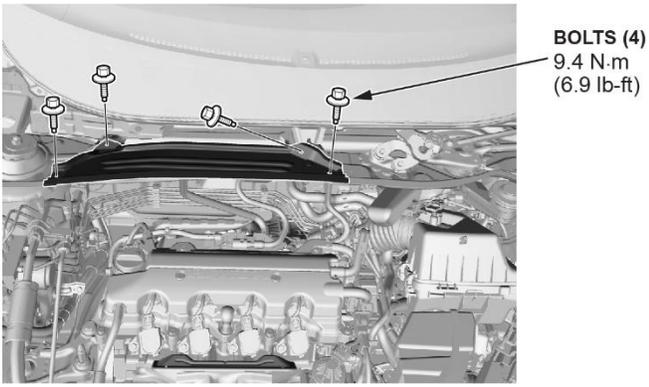
5. Remove the dashboard upper lid.

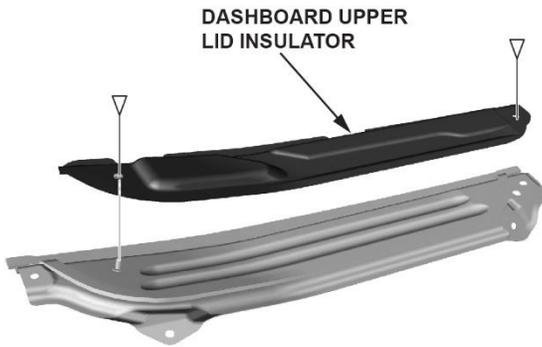
6. If necessary, remove the dashboard upper lid insulator.

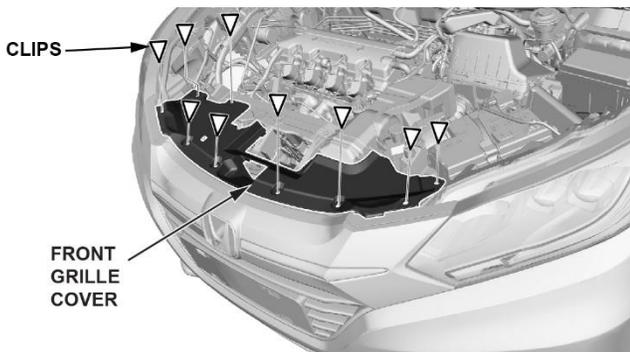
7. Remove the front grille cover.

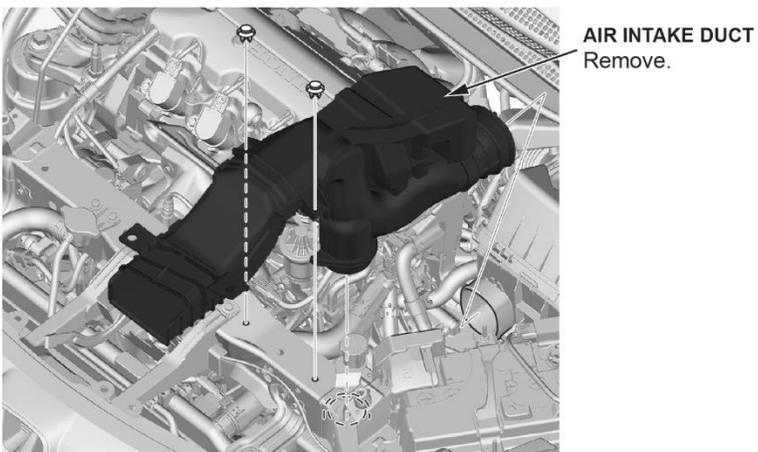
8. Remove the air intake duct.

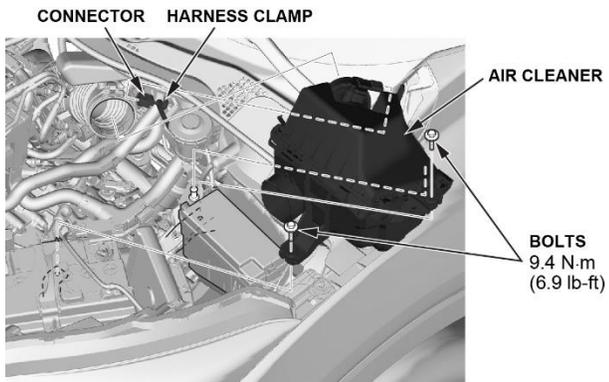
9. Remove the air cleaner.

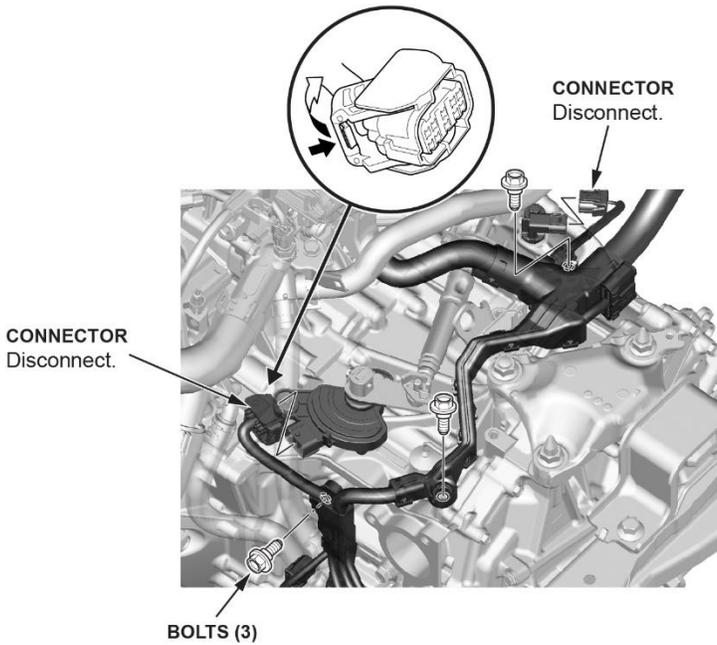
11. Remove the bolts and disconnect the connectors.

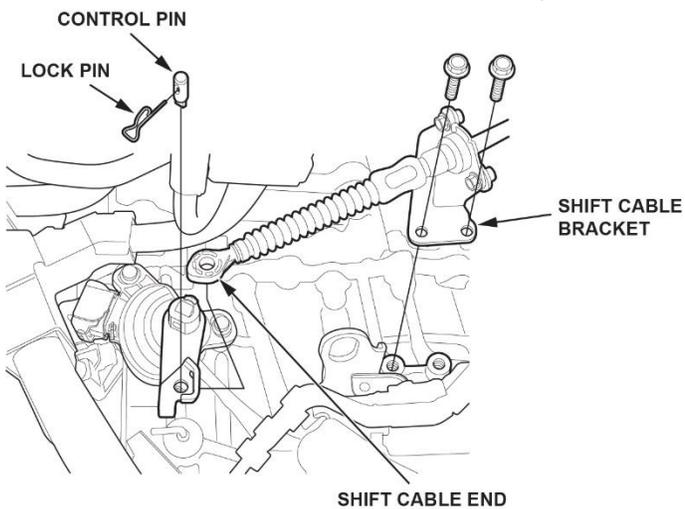
12. Remove the lock pin, control pin, shift cable bracket, shift cable, and engine wire harness.

NOTE: Do not bend the shift cable excessively.

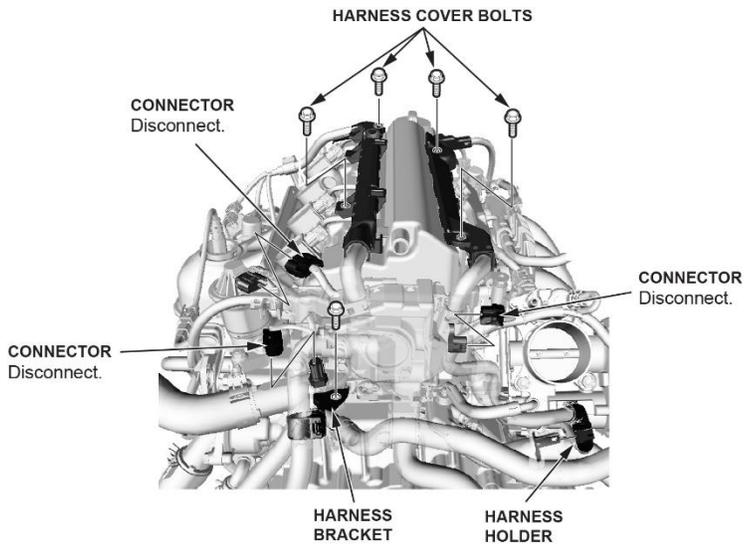
13. Remove the engine cover, harness cover bolts, harness bracket, harness holder, disconnect the connectors.

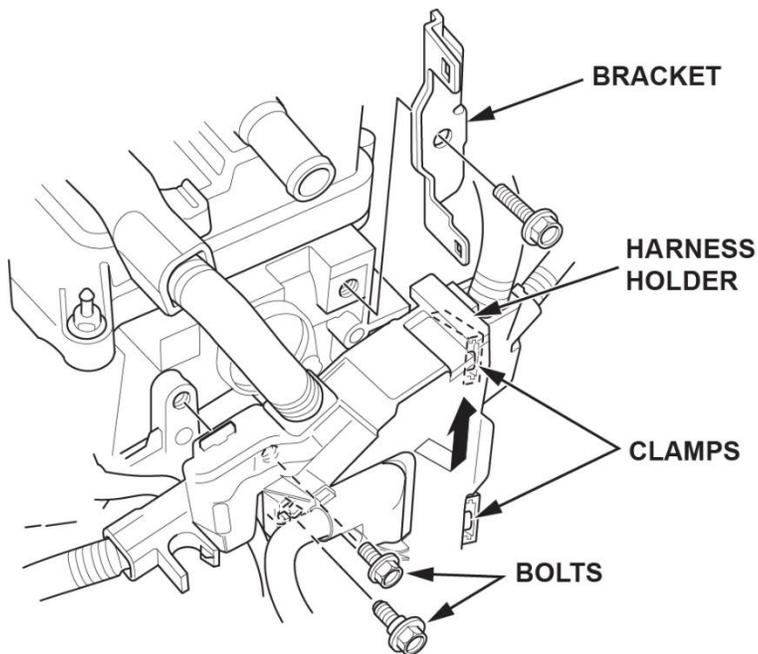
14. Remove the bolts, clamps, and move the harness holder, then remove the bracket.

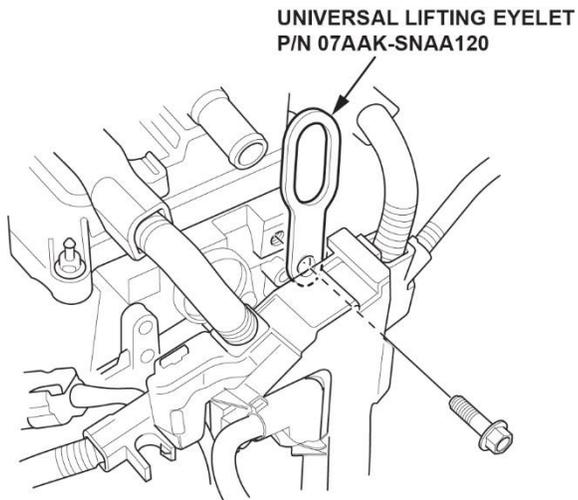
15. Attach the universal lifting eyelet to the cylinder head.

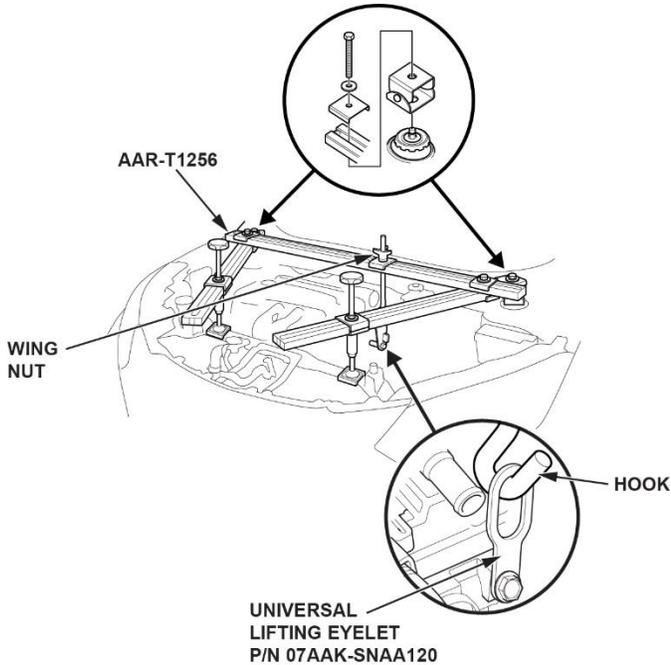
16. Install the engine support hanger, then attach the hook to the slotted hole in the universal lifting eyelet. Tighten the wing nut by hand and support the engine/transmission.

NOTE: Be careful when working around the windshield.

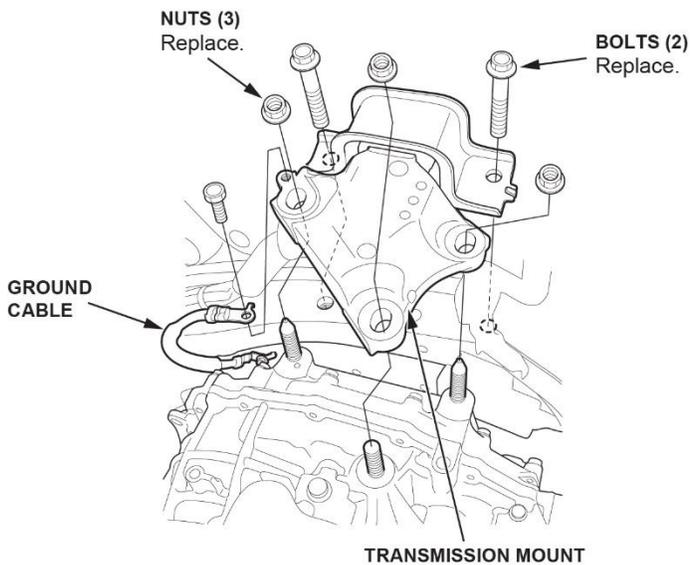
17. Remove the ground cable and the transmission mount.

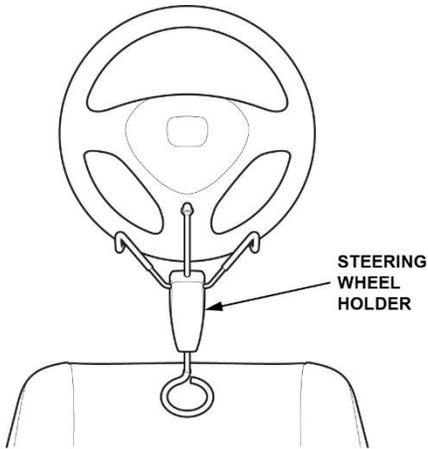
20. Set the steering column to the center tilt position and to the center telescopic position. Center the steering wheel spoke angle and install a steering wheel holder.

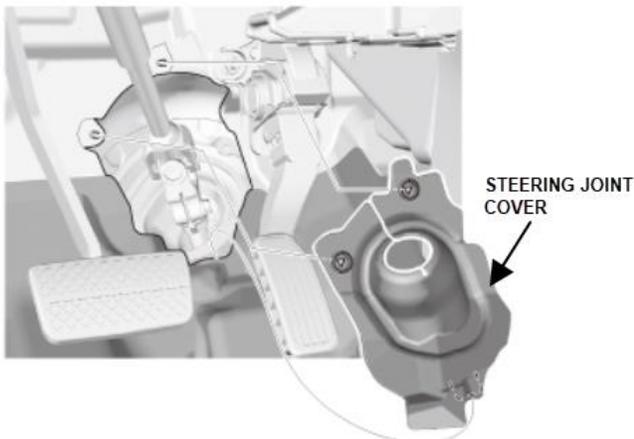
21. Remove the steering joint cover.

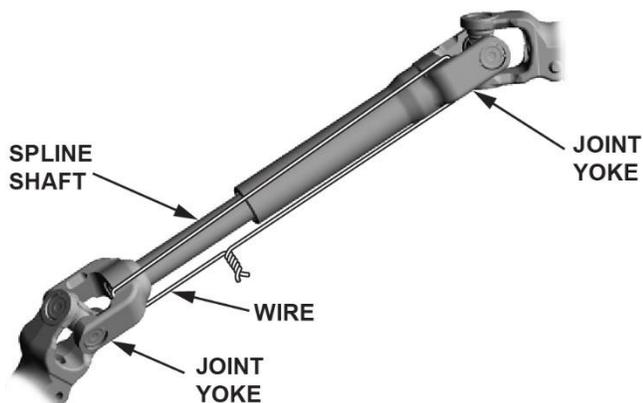
22. Hold the spline shaft on the column with a piece of wire between the joint yoke of the spline and the joint yoke of the spline tube to prevent the lower spline shaft from coming out.

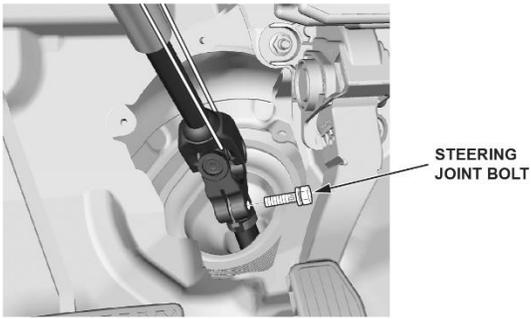
23. Remove the steering joint bolt.

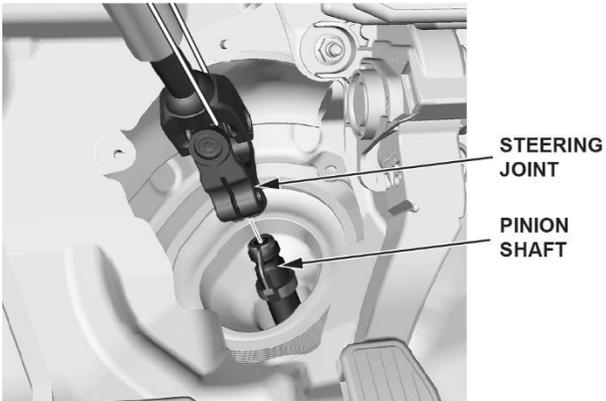
24. Disconnect the steering joint from the pinion shaft.

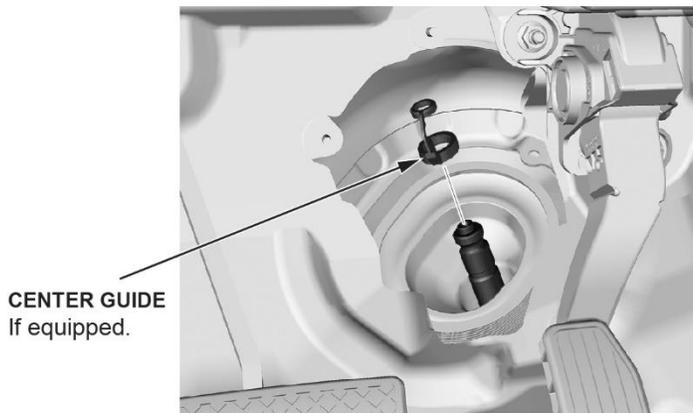
25. Remove the center guide (if equipped) and discard it.

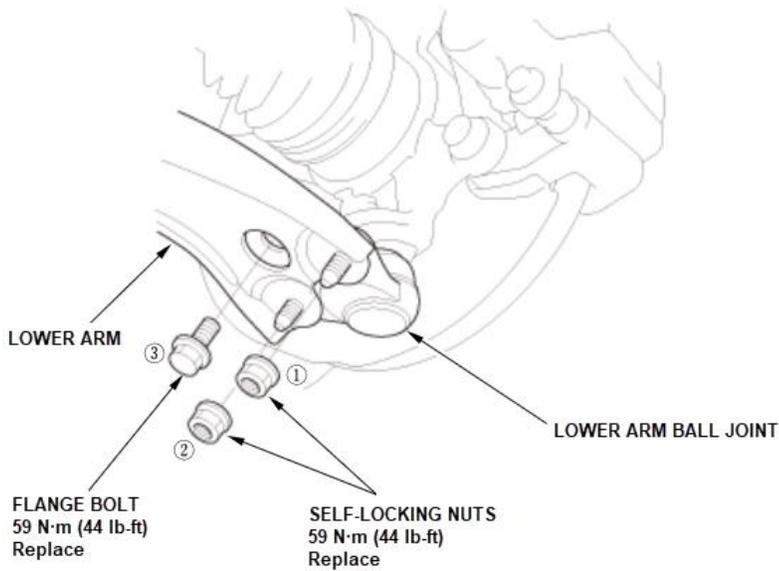
26. Remove the flange bolt and self-locking nuts, then disconnect the lower arm from the lower arm ball joint.

- Use new self-locking nuts and the flange bolt during reassembly.
- Tighten the self-locking nuts and the flange bolt in the sequence shown.

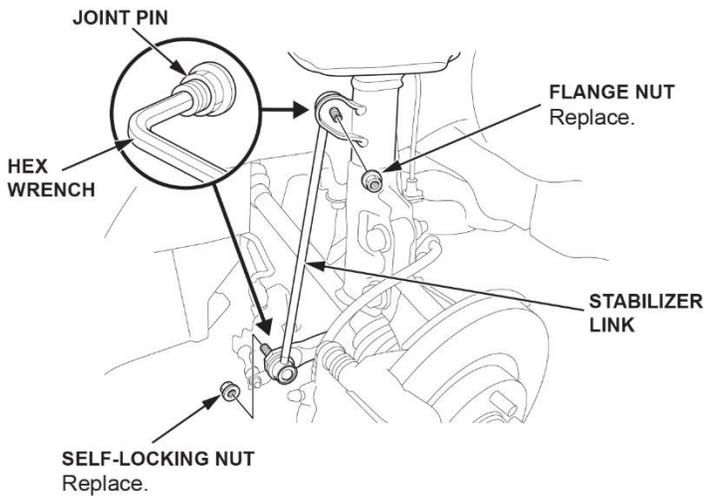
27. Remove the self-locking nut and the flange nut while holding the joint pin with a hex wrench and remove the stabilizer link.

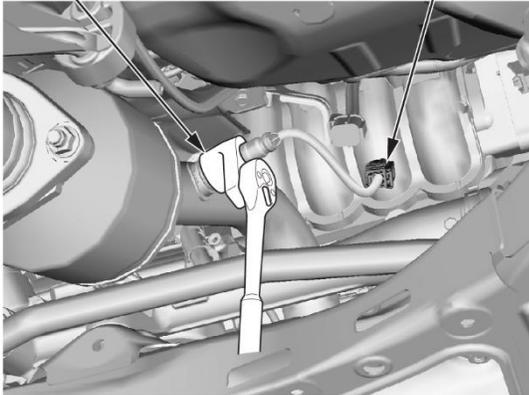
28. Disconnect the connector and remove the secondary HO2S.

SECONDARY HO2S
45 N·m (33 lb-ft)

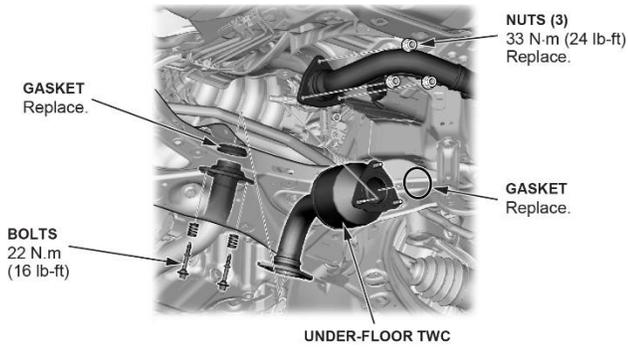
29. Remove the under-floor TWC and the gaskets.

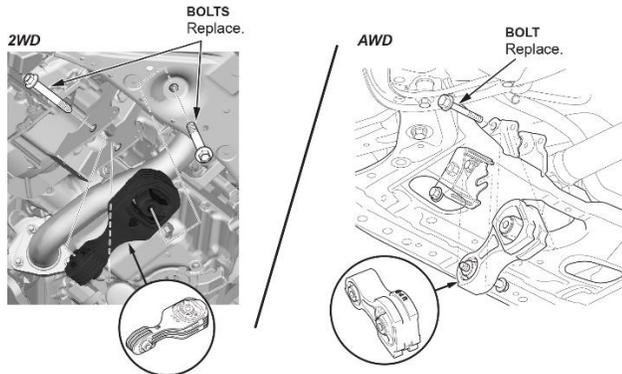
30. Lift and support the engine with a transmission jack and a wood block under the oil pan and remove the torque rod.

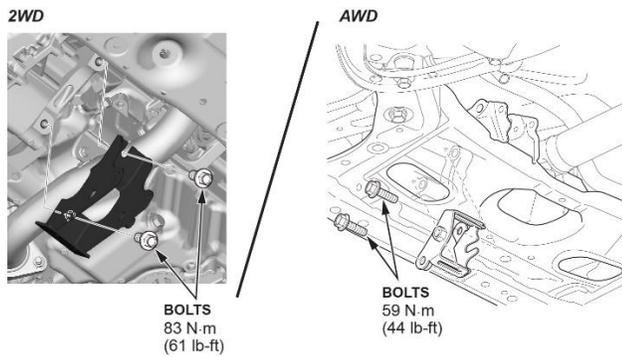
31. Remove the torque rod bracket as needed.

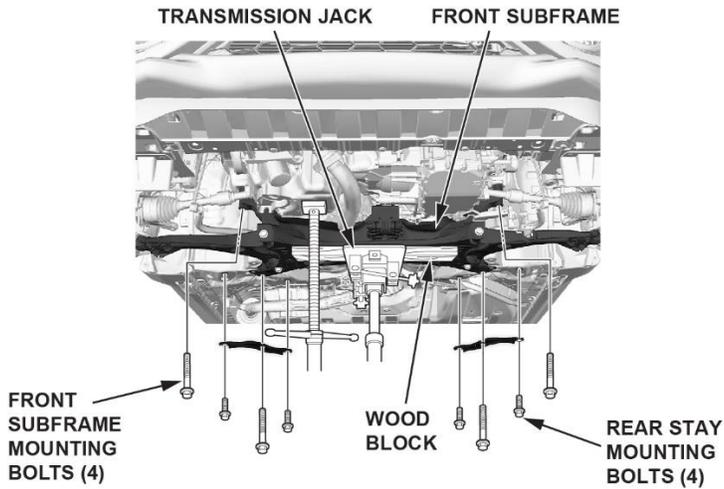
32. Attach a wood block (A) to the lower center of the front subframe, attach a transmission jack (C) to the center of the wood block. Support the front subframe securely by raising the transmission jack, remove the front subframe mounting bolts (D) and the subframe rear stay mounting bolts (E).

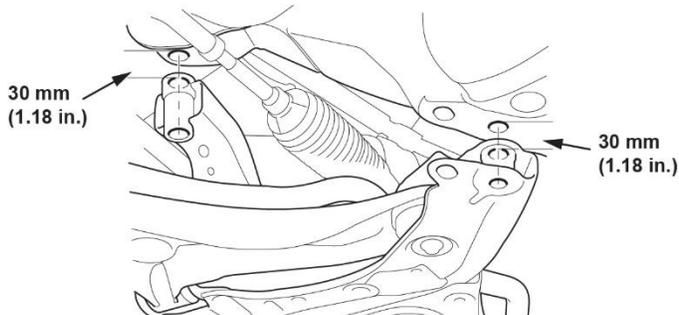
33. Lower the jack slowly until the subframe of the body has dropped about **30 mm**.
NOTE: Do not lower the subframe more than required.

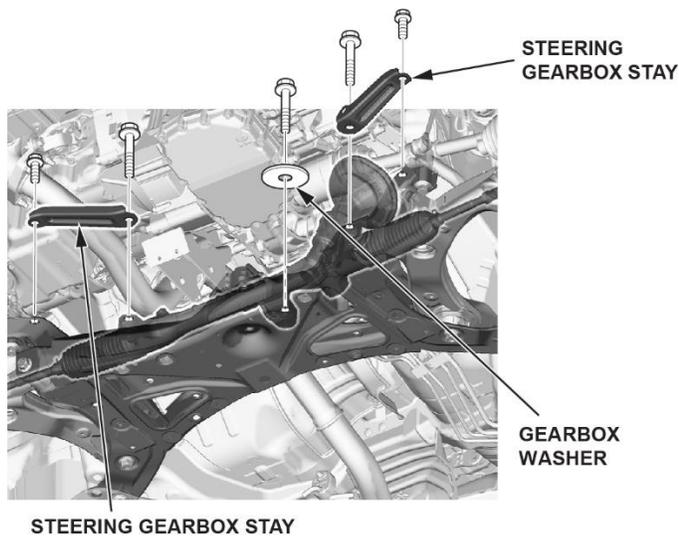
34. Remove the steering gearbox stays and remove the gearbox washer.

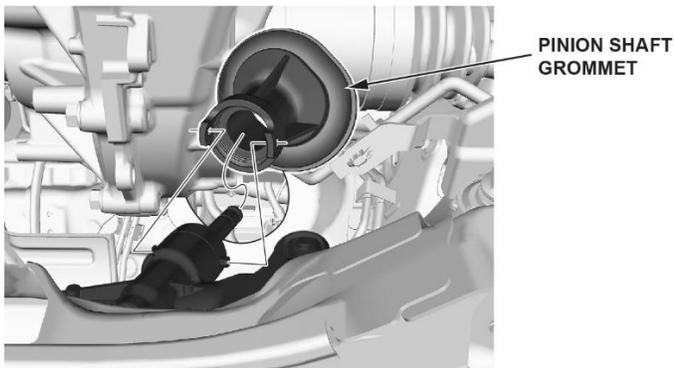
35. Remove the pinion shaft grommet.

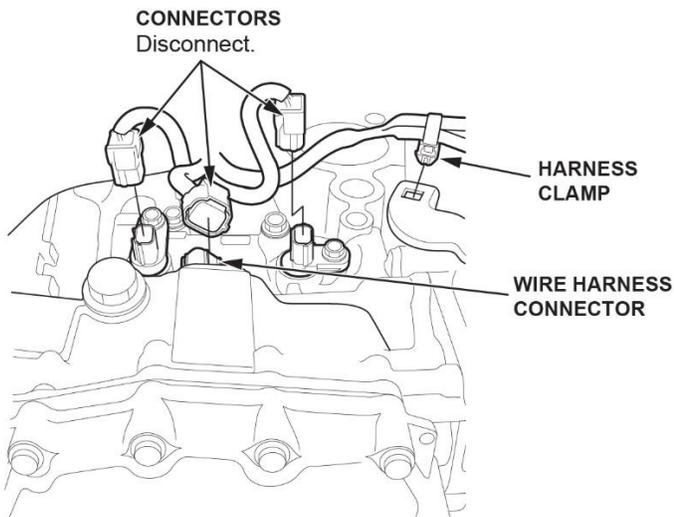
36. Disconnect the connectors and remove the harness clamp.

NOTE: To prevent damage, cover the solenoid wire harness connector using a shop towel.

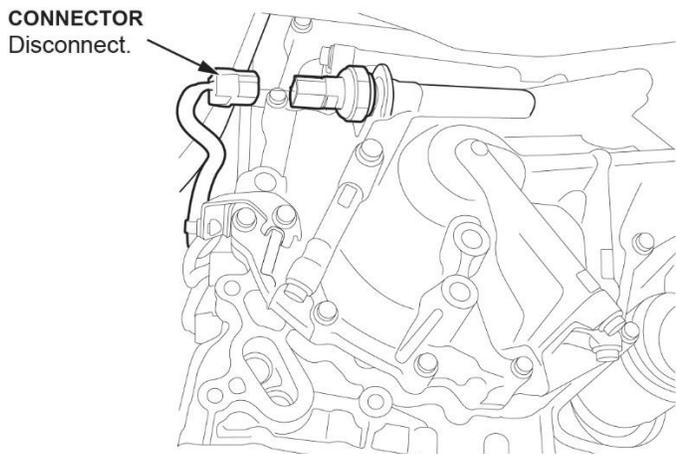
37. Disconnect the connector.

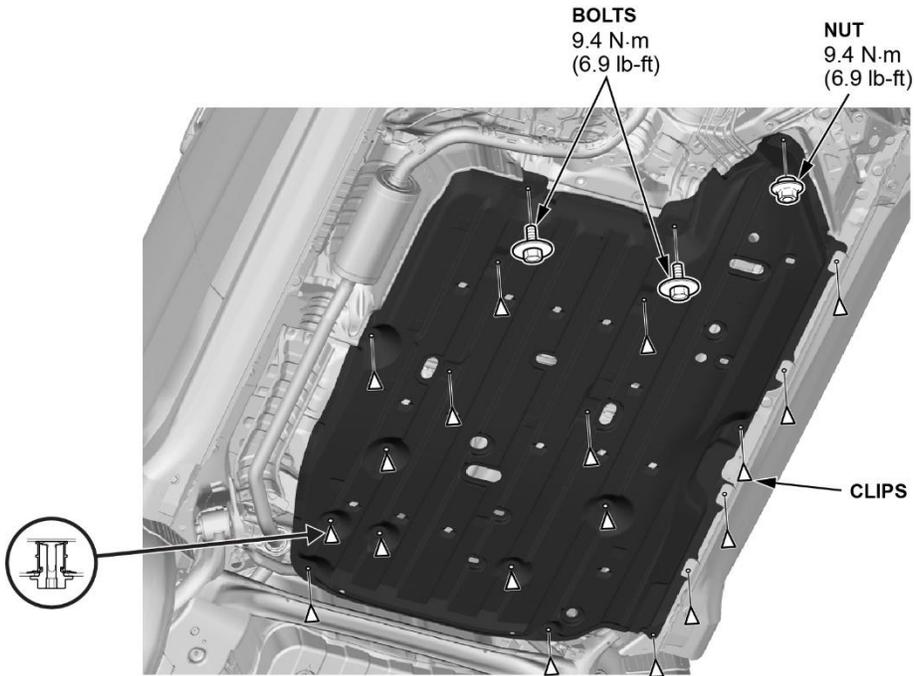
38. Remove the front floor undercover.

NOTE: The retainer clips stay in the front floor under cover.

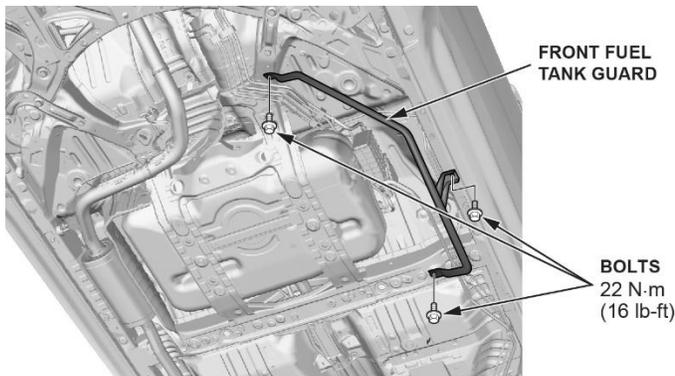
39. Remove the front fuel tank guard.

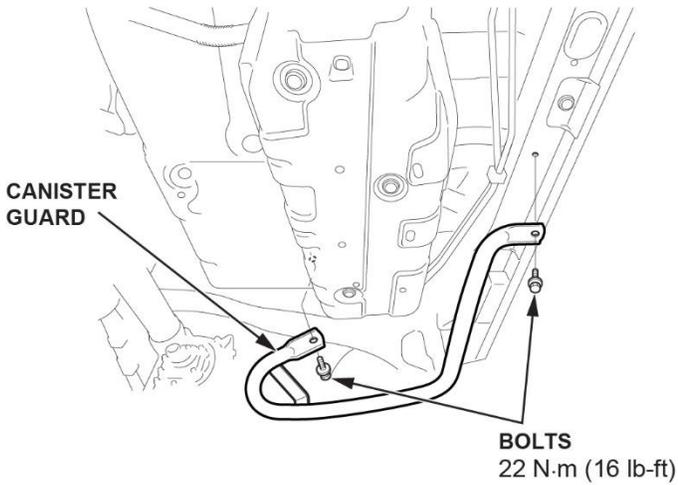
40. Remove the canister guard.

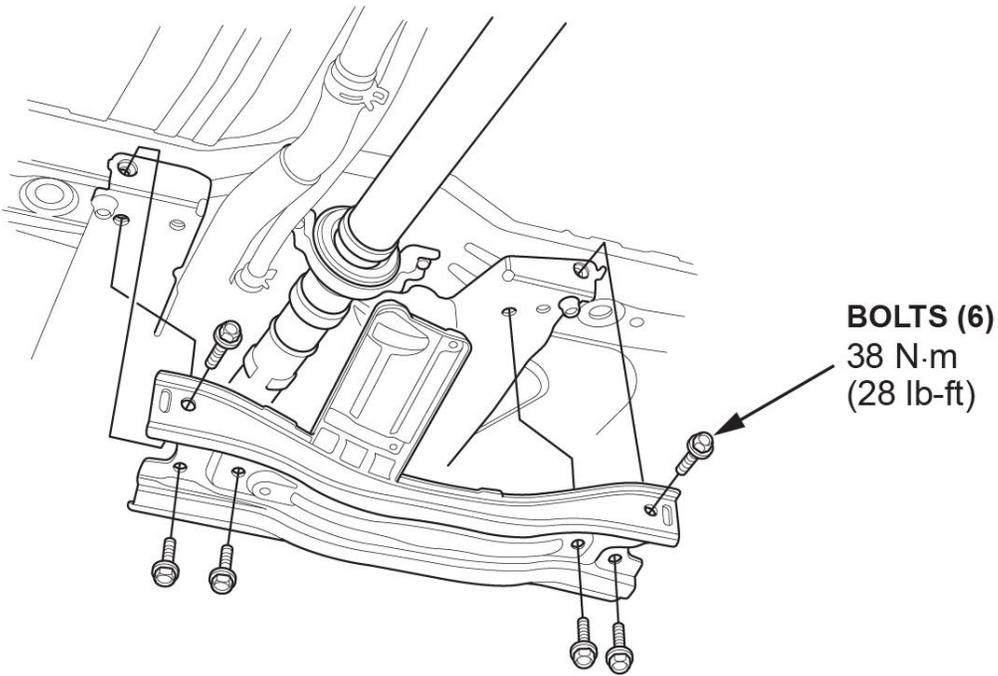
41. Remove the front center member.

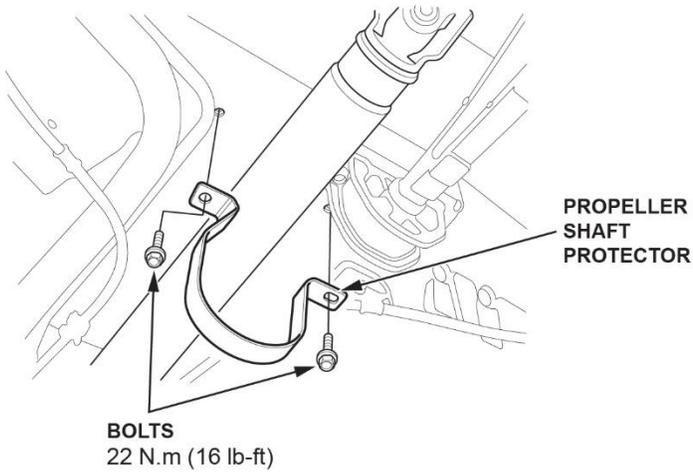
42. Remove the propeller shaft protector.

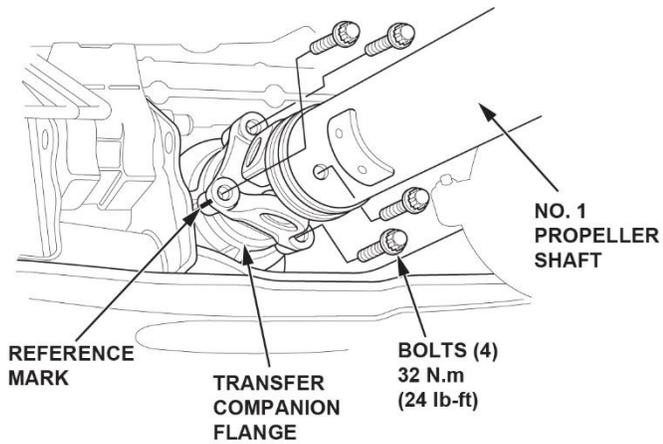
43. Make a reference mark across the No. 1 propeller shaft, transfer the companion flange, then remove the No. 1 propeller shaft flange bolts.

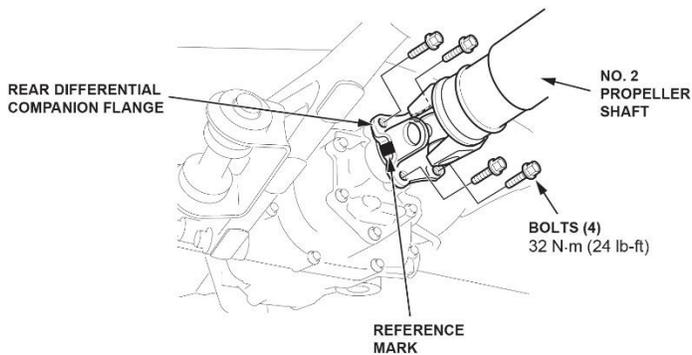
44. Make a reference mark across the No. 2 propeller shaft, the rear differential companion flange, then remove the No. 2 propeller shaft flange bolts.

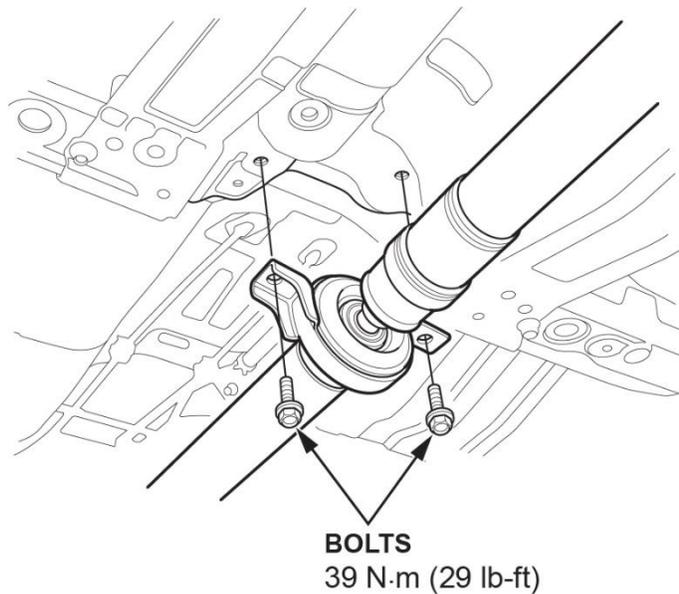
45. Remove the center support bearing mounting bolts.

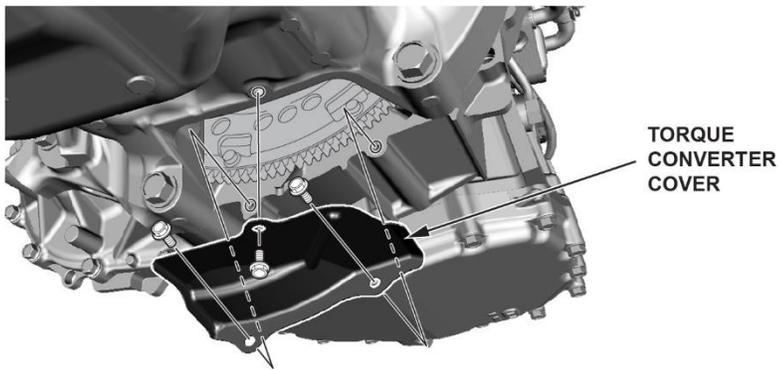
46. Remove the torque converter cover.

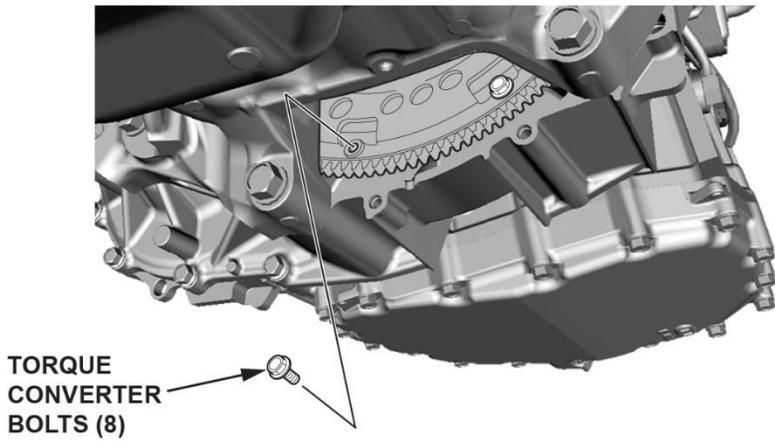
47. Remove the 8 torque converter bolts.

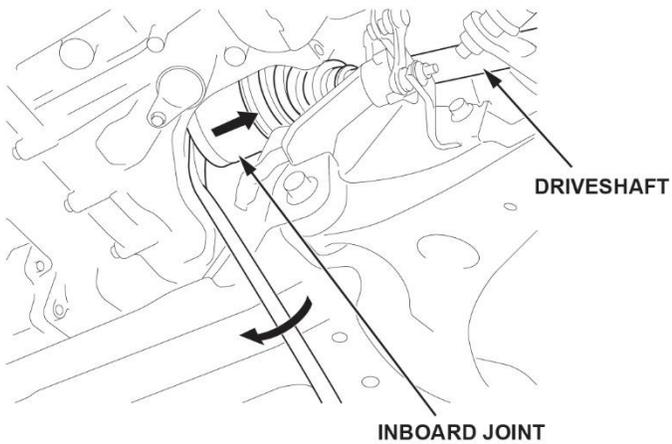
LEFT DRIVESHAFT

48. Disconnect the left driveshaft inboard joint and secure the driveshafts to the body with straps.

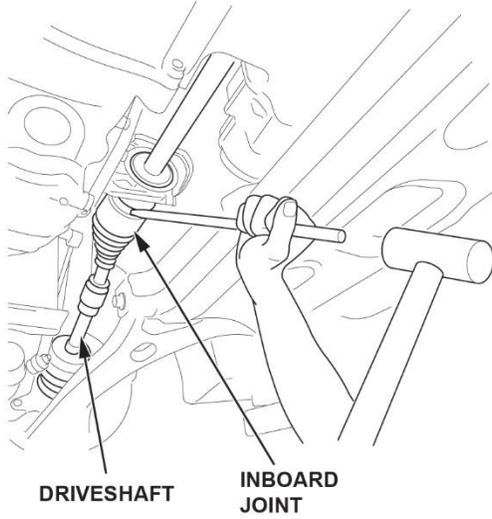
RIGHT DRIVESHAFT

49. Disconnect the right driveshaft inboard joint and secure the driveshaft to the body with straps.

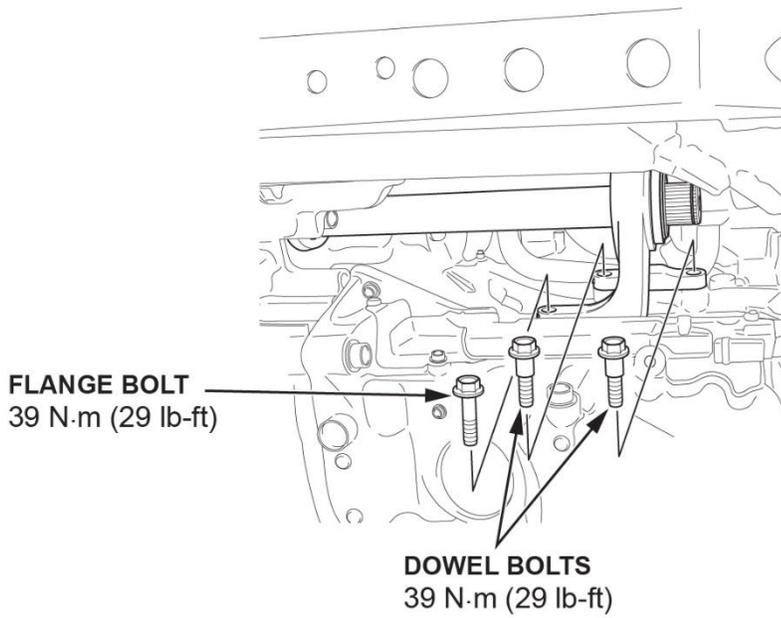
50. Remove the intermediate shaft bolts.

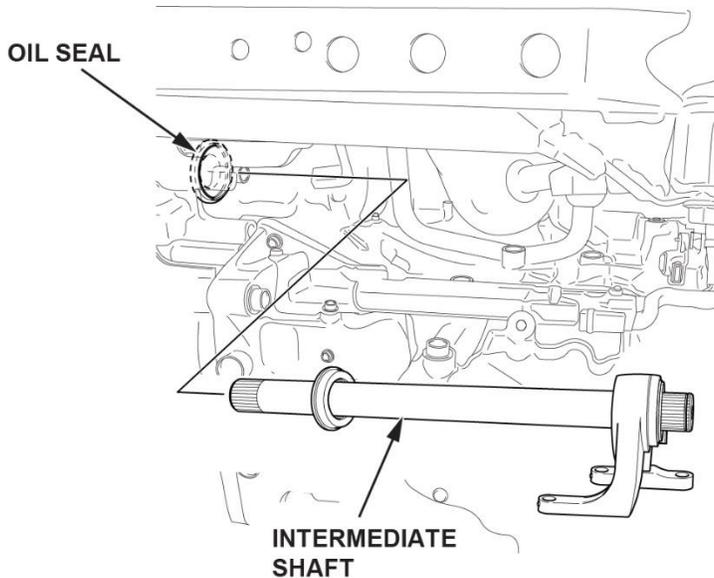
51. Remove the intermediate shaft.

NOTE: Hold the intermediate shaft horizontal until it is clear of the differential to prevent damaging the oil seal.
